ECHO Research Notes

Analysis of Water Quality Results from Biosand Water Filtration Systems

Shaun Snoxell and Dr Krit Suriyachaipun

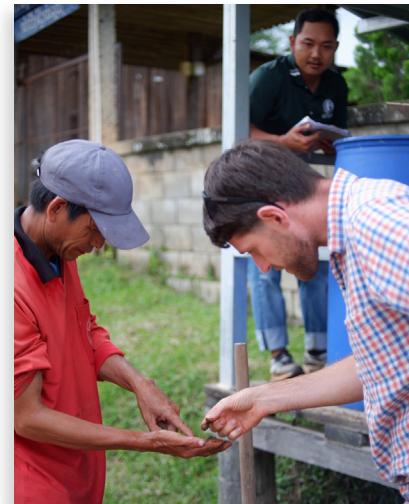
Figure 2. Shaun inspecting the biofilm layer in barrel 2 of a system in Houyypa village.
Source: ECHO Asia

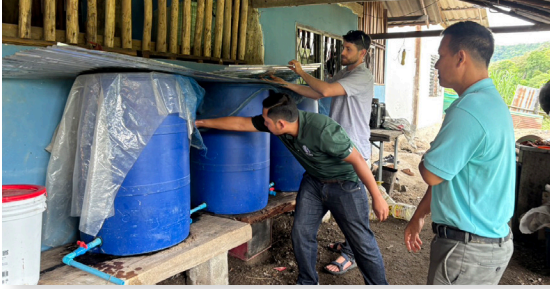
Figure 3. Checking a bio-sand water filter and taking water samples in Pangfan village.
Source: ECHO Asia

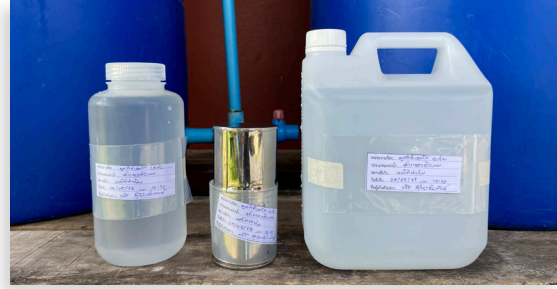
Figure 4. Water samples being prepared for submission to the laboratory.
Source: ECHO Asia

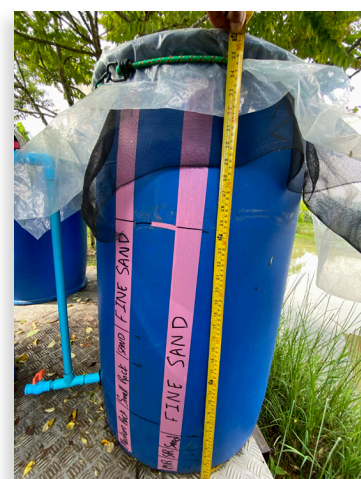
Figure 5. Recording specifications of the thickness of layers of different particle sizes. Source: ECHO Asia

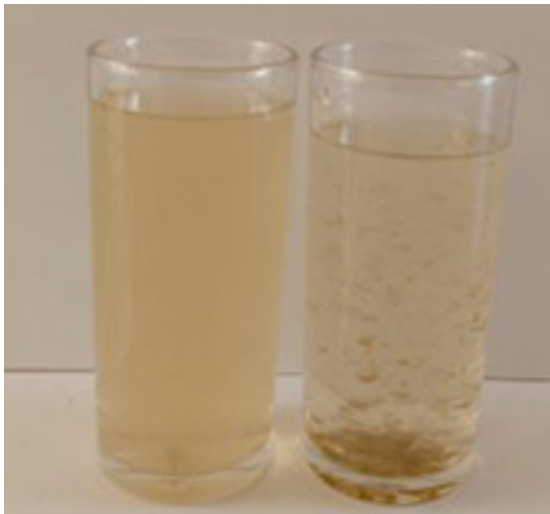
Figure 6. Before (left) and after (right) filtration with the first design.
Source: ECHO Asia

Table 2 and figures 6 and 7 below show that the second design was much more effective at improving color and turbidity results and reducing iron content. Even though the first design resulted in visibly dirty water after filtration, both the first design and the modified design had coliforms detected after filtration. Both designs effectively removed *E. coli*.

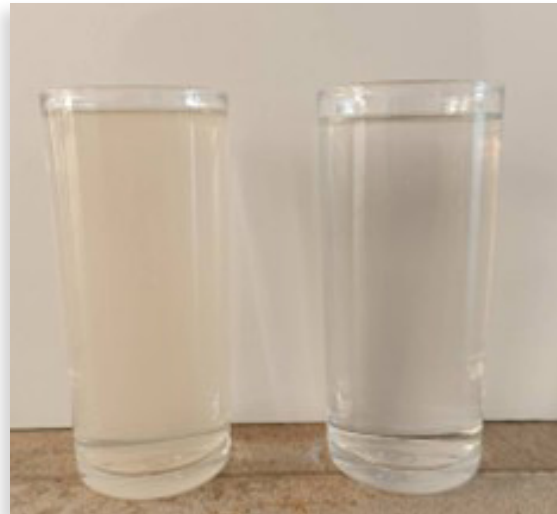
Figure 7. Before (left) and after (right) filtration with the modified design.
Source: ECHO Asia

- Reducing the flow rate and speed into the first barrel
 - Letting water settle in a holding tank prior to filtration
 - Reducing the particle size of sand and gravel, and increasing the depth of the layers with smaller particles
 - Removing the char from a mesh bag, and instead placing it in a layer in the barrel
1. Crushing char to smaller particle size (<2 cm diameter)
 2. Soaking char in clean water prior to installing, and removing floating particles of char (assumed to be less water-permeable)

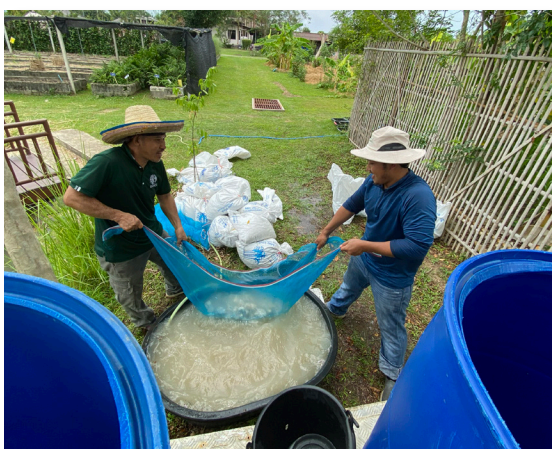
Figure 8. Washing gravel prior to installation.
Source: ECHO Asia

Solutions [2016] design, with a notable change in that the biochar was placed in a mesh bag prior to adding to the third barrel, for ease of replacement. In addition, ECHO team gauged the relative quantity of various sand and gravel layers by eye based on their experience rather than following the exact ratios outlined in the Aqueous Solutions [2016] design.

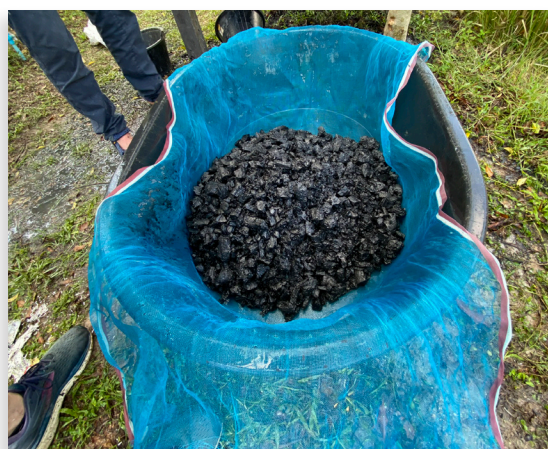
Figure 9. Wrapping char in mesh bag ready for installation.
Source: ECHO Asia

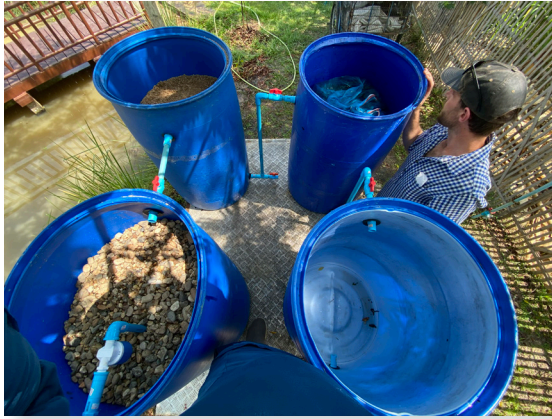
Figure 10. Building biosand filter.
Source: ECHO Asia

Raw water from the fish pond, which was highly turbid and untreated, was pumped twice daily at 8 am and 3 pm into the pre-filter barrel (tank 1) of a 4-barrel biosand filter design described by Aqueous Solutions (<http://edn.link/fmrxt>; 2016). Each of the two daily pumping periods were approximately 2 hours in duration, which was sufficient for 200 litres of water to accumulate in the last barrel (tank 4-that stores the cleaned water). At the end of each pumping period, when the last barrel had reached full capacity, the water in the last barrel was drained and discarded. Water was constantly maintained in tank 1, 2, and 3 at maximum capacity to ensure the survival of the biofilm layer. This procedure was carried out daily for 30 days, excluding Saturdays and Sundays. The purpose was to simulate a realistic maximum-use scenario, and allow the development of a biofilm layer prior to water quality sampling.

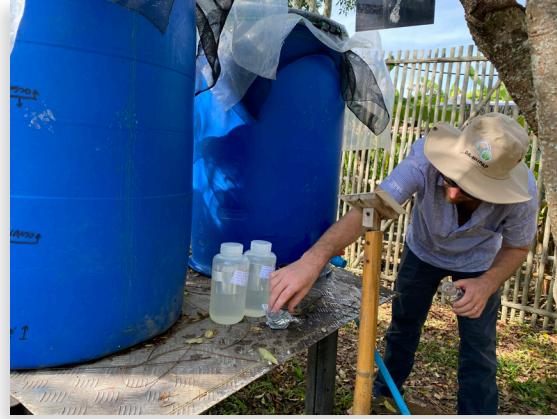
Figure 11. Taking water samples for laboratory testing. Source: ECHO Asia

After the system had been in operation for 30 days, water samples were collected for analysis of water quality based on the specified parameters, such as turbidity, pH, total dissolved solids (TDS), and coliform bacteria. A pre-filtration sample from the intake directly into tank 1 was taken, and a post-filtration sample from the tap from tank 4.

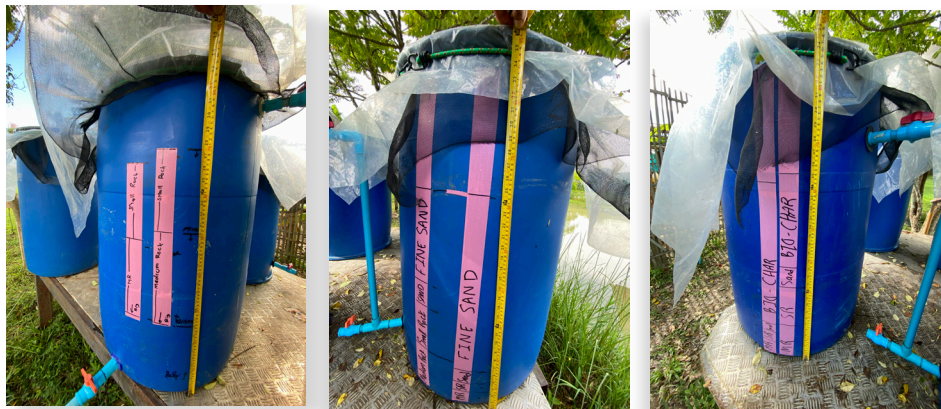
Figure 12. Pink strip showing round 1 and round 2 material depths for the first (left/gravel), second (middle/sand), and third (right/char) barrels. Source: ECHO Asia

Table 4 shows the changes made in filter materials from the first to second round of tests, while figure 12 shows the layer height visually.

Barrel	Round 1		Round 2	
1. Gravel Roughing Pre-filter	Gravel	20 cm	Big stone	20 cm
	Medium stone	20 cm	Medium stone	25 cm
	Big stone	25 cm	Gravel	25 cm
2. Slow Sand Biofilter	Fine sand	24 cm	Fine sand	45 cm
	Coarse sand	8 cm	Coarse sand	4 cm
	Gravel	15 cm	Gravel	4 cm
	Medium stone	7.5 cm	Medium stone	7 cm
3. Biochar Adsorber	Biochar	25 cm	Fine sand	45 cm
	Coarse sand	6 cm	Coarse sand	4 cm
	Gravel	15 cm	Gravel	4 cm
	Medium stone	17 cm	Medium stone	7 cm
